INDEPENDENT ORBITER ASSESSMENT

ANALYSIS OF THE MAIN PROPULSION SYSTEM

WORKING PAPER NO. 1.0-WP-VA86001-22

INDEPENDENT ORBITER ASSESSMENT
ANALYSIS OF THE ORBITER MAIN PROPULSION SYSTEM

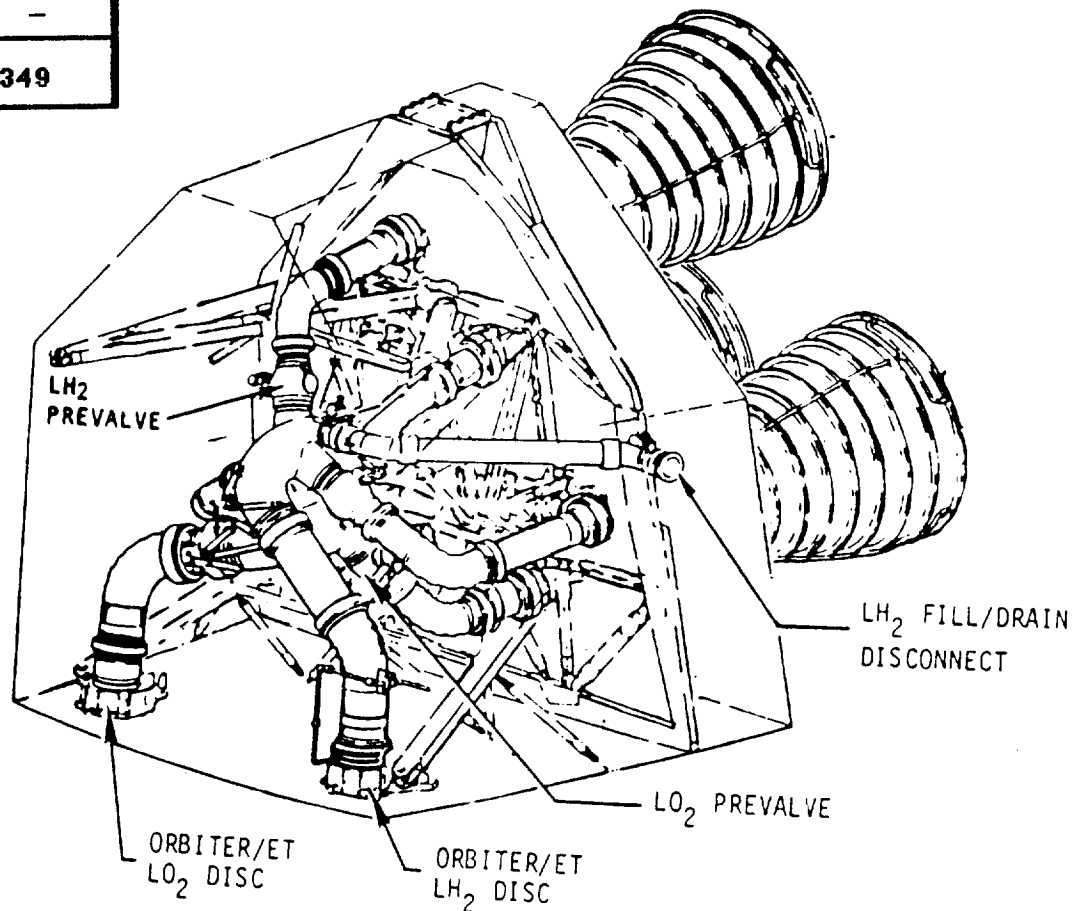
ORBITER MPS SUMMARY		
CRIT	#FM	#PCI
1/1	129	129
2/1R	142	142
2/2	30	30
3/1R	94	25
3/2R	70	23
3/ 3	225	—
TOTAL	690	349

Figure 1 presents a summary of the failure criticalities for each of the MPS subsystems.

Of the 690 failure modes analyzed, 349 were determined to be PCIs.
